LANDSLIDES AND RELATED FEATURES

OF THE MYRTLE, W. VA. QUADRANGLE

by
William F. Outerbridge
1982

OPEN FILE MAP 82-51 (G-15)

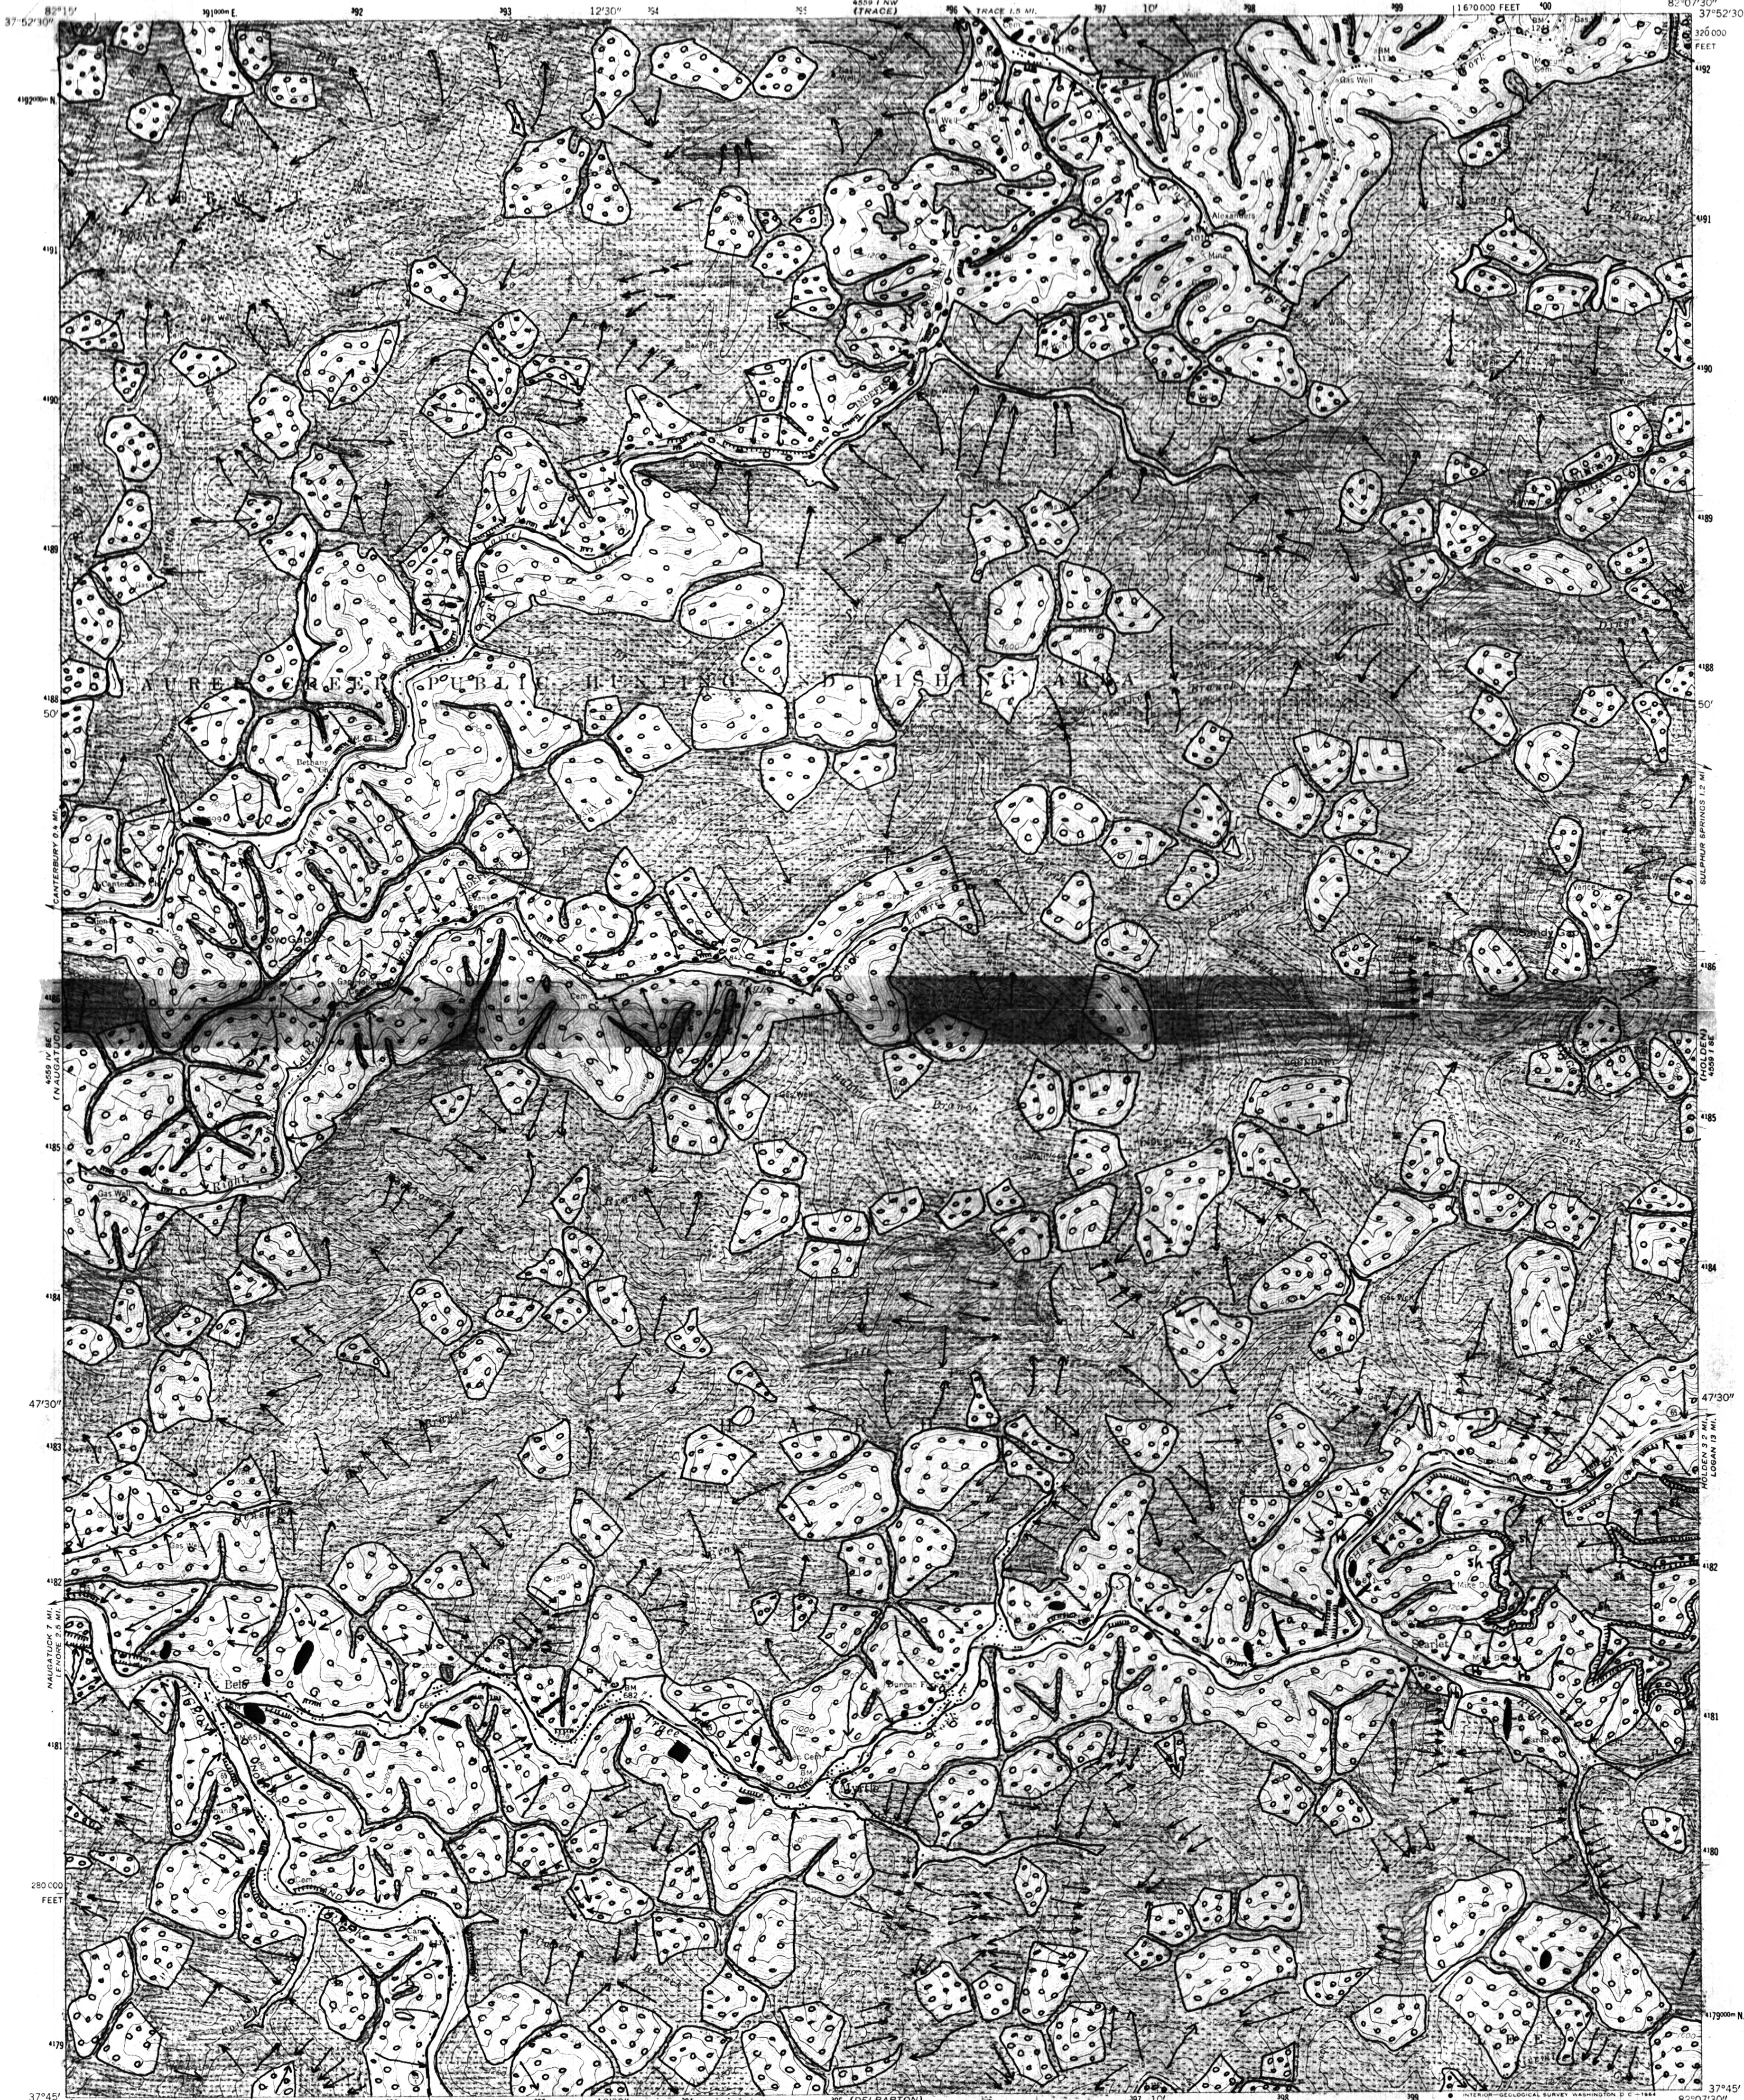
MYRTLE, W. VA.
SW/4 HOLDEN 15 QUADRANGLE
N3745-WB207.5/7.5
1963

Landslides and related features interpreted
from aerial photographs:
1:60,000 (black and white) 1959
1:125,000 (color Infrared) 1973

ACTIVE OR RECENTLY ACTIVE LANDSLIDE
Complex landslide composed of earthflow, debris
slide, earth and rock slump. Identified from
historical records, and from scars, debris and
other field evidence. Ground extremely unstable;
sliding accelerated by excavation, loading and
changes in drainage conditions. May include
areas with several active slides too small to
be shown separately. Questioned where doubtful.

OLD LANDSLIDE
Area of extensive hummocky ground caused by
earthflow and earth and rock slump. Lacks
clear evidence of active sliding. Relatively
stable in natural, undisturbed state,
generally not affected by small structures properly
sited in areas away from the edge of the toe;
can be reactivated by extensive, rapid exca-
vation, loading, and changes in ground water
surface water conditions. Area of old landslide
probably includes recent ones not identified
from field evidence or otherwise documented.
Upslope boundary of landslide generally defined
by modified scarp, but downslope (toe) may be
gradational and not well defined. Questioned
where doubtful.

COMBINATION LANDSLIDE
Area of recent and old slides in which
individual slides are not identified.

COLLUVIAL SLOPE
Valley wall along major streams with slope as
steep as 40° (85%); stony, clayey silt soil up
to 50 ft. (15 m) thick; commonly buttressed by
a terrace or bench at the toe of the slope; very
susceptible to sliding by cutting of toe area,
removal of terrace or bench, and overloading;
slide commonly activated without apparent cause.

**AREAS SUSCEPTIBLE TO DEBRIS FLOWS AND DEBRIS
AVALANCHES**
Primarily shallow, narrow ravines and chutes with
accumulation of stony colluvium generally 10 ft.
(3 m) or less in thickness; susceptible to rapid
movement during intense rainfall. Most ravines
and chutes designated show evidence of former
debris flows and avalanches. Symbol & design-
ates historical debris flow or debris avalanche.

AREAS SUSCEPTIBLE TO ROCKFALL
Steep, locally vertical, natural and man-made
slopes and cliffs, 15 ft. (4.5 m) or more high;
formed dominantly of sandstone, limestone, sandy
shale, mudstone and claystone. Interbedded mud-
stone, claystone and shale weather rapidly leaving
sandstone and limestone rock faces unsupported.

SOIL AND ROCK SUSCEPTIBLE TO LANDSLIDING
Soil and rock similar to that involved in land-
slides elsewhere in map area; primarily areas
underlain by claystone, mudstone and shale
associated with other rock types. Rock weathers
rapidly on exposure forming clayey soil highly
susceptible to sliding. Includes coves (U-shaped,
shallow valleys) containing thick layers of clayey
soil that are very susceptible to sliding where
excavation breaks continuity of slope and where
overloaded by artificial fill.
